Tesla Model S

Model S 85kWh electric drivetrain, LHD

2014 ★★★★★

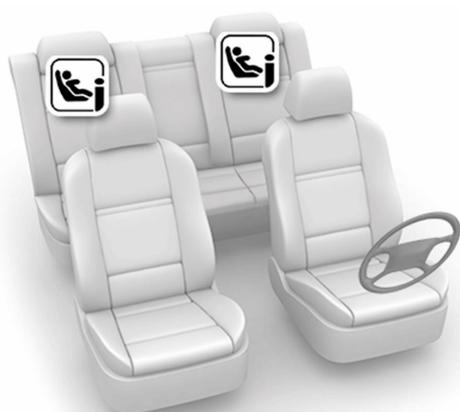
Isifix

Safety features score **3 pts**
Installation check score **10,8 pts**

The Model S scored maximum points for its protection of the child dummies in the dynamic tests. Both dummies were seated in rearward-facing restraints and showed good protection in the frontal impact. In the side impact, both dummies were properly contained within the protective shells of their restraints, minimising the risk of head contact with parts of the vehicle interior. The front passenger airbag can be disabled through the user menu, allowing a rearward-facing restraint to be used in that seating position. However, the interface is not clear in all languages about the actions being taken to set the airbag status and the system was not rewarded. All of the restraints for which the car is designed could be properly installed and accommodated with the exception of the Group I universal restraint in the rear outboard seats. While the seat could be installed, the seat cushioning made engagement of the ISOFIX probes difficult. Integral child restraints are available as an optional third row in the Model S.

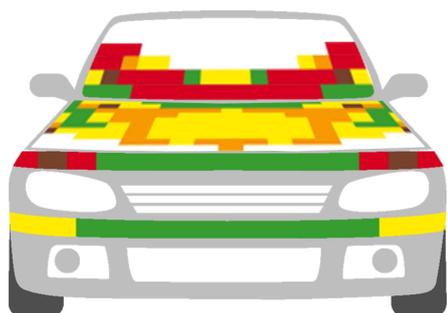
| HEAD | 13,9 pts |
| PELVIS | 4,1 pts |
| LEG | 5,8 pts |

The Tesla is equipped with an 'active' bonnet. When the system detects that a pedestrian has been struck, actuators lift the bonnet to provide greater clearance to hard structures underneath. Tesla showed that the system detects all statures robustly over a range of speeds and the car was tested with the bonnet in the deployed position. Protection was adequate or marginal over most of the surface of the bonnet with poor results recorded only at the base of the windscreen and on the stiff screen pillars. The bumper offered predominantly good protection to pedestrians' legs while the front edge of the bonnet gave good results towards the centre of the car but poor results at the outside edges.
